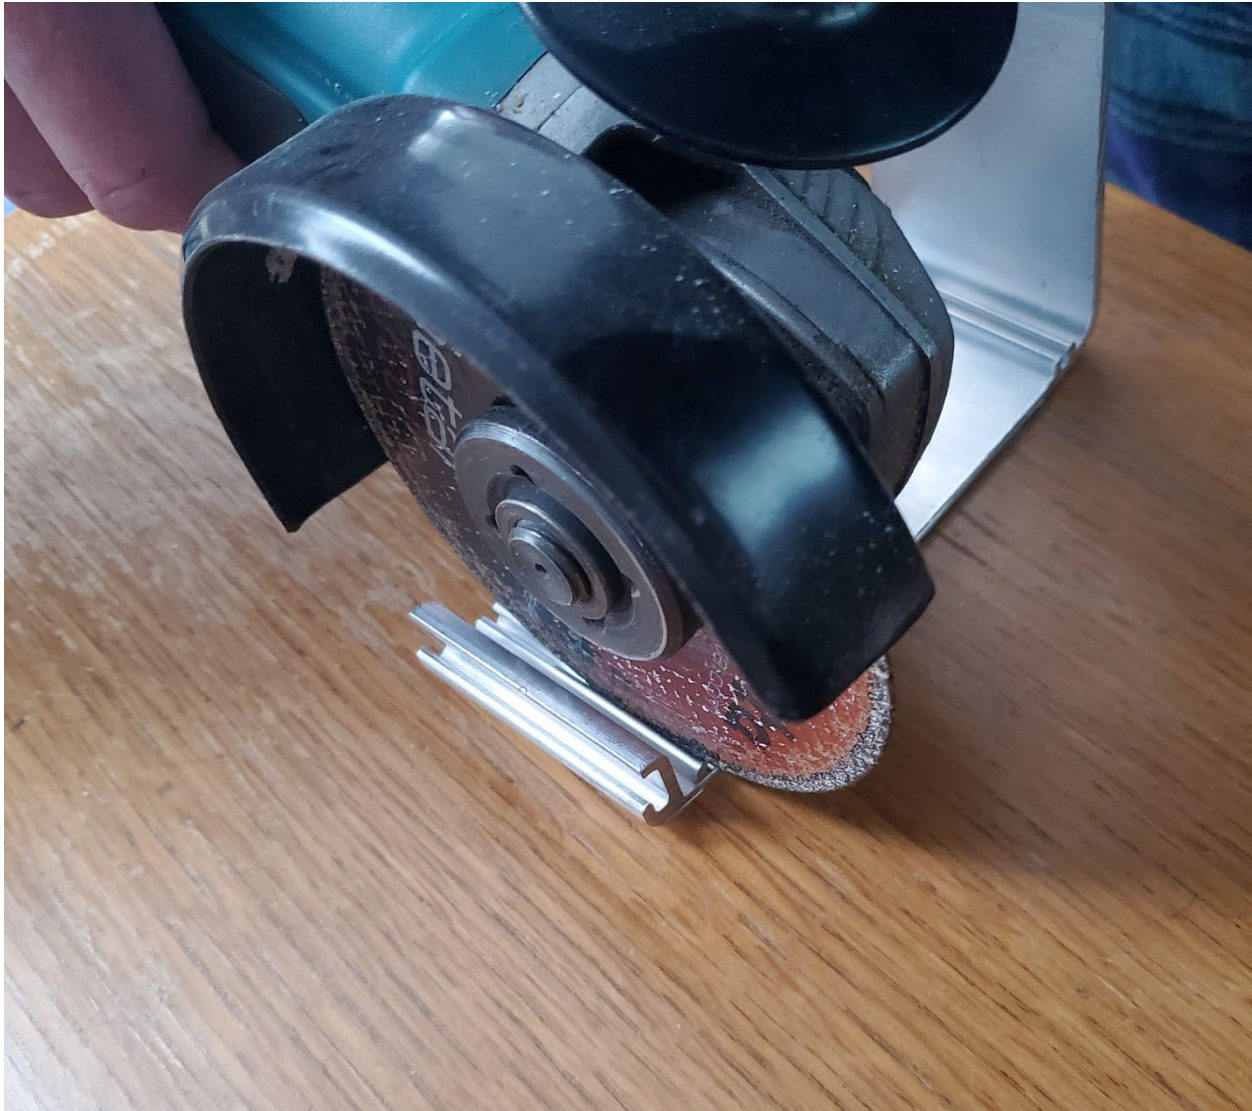
Since the screw shaft is a much harder metal than the extruded aluminum, drilling it out doesn't work. The best method is to use an angle grinder with a blade narrower than the extruded channel (this blade below is 0.045" thick) that the screw goes into, to grind out the broken off screw shaft.

Then use a comparable new self-tapping screw (bring one of the other screws with you to the hardware store).
